MACHINE SERVICE BULLETIN #32

SUBJECT: Interference between
Lug in Carriage & K843D in
"2" Series Machines

DATE: March 1, 1926

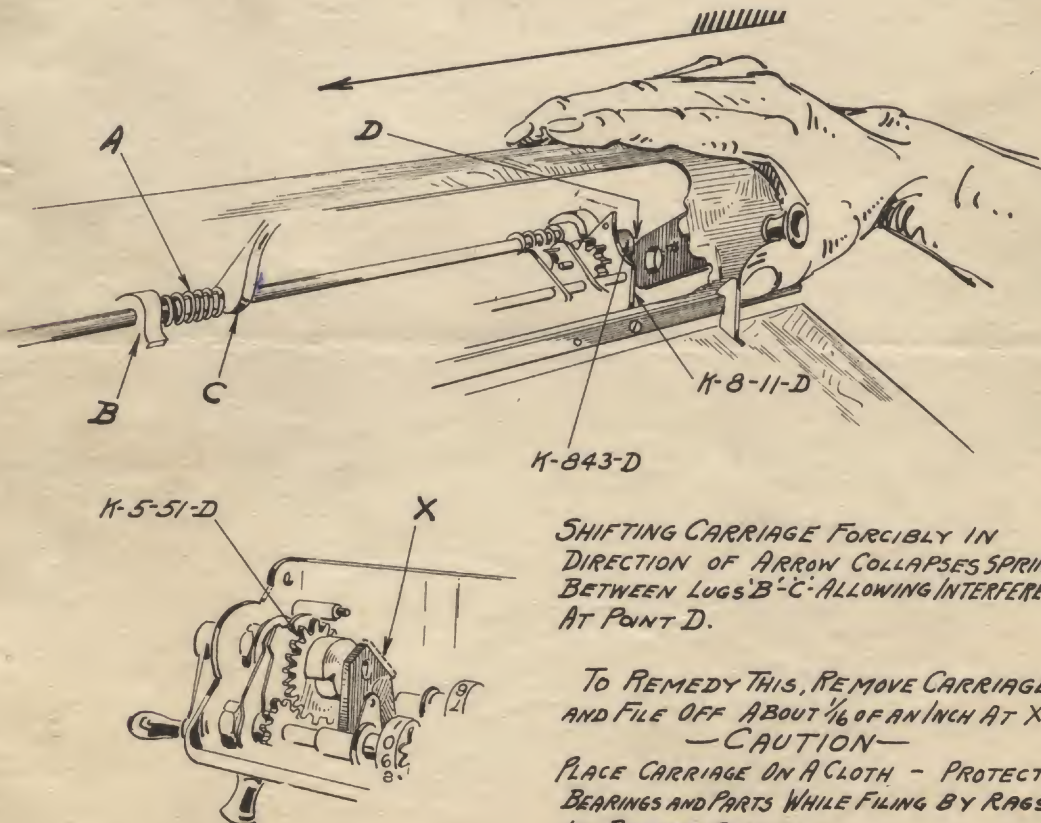
We have recently discovered that when shifting the carriage from the extreme right hand position to the extreme left hand position forcibly, by the use of the carriage lift handle, K5-85D (in this manner only) that it is possible for an interference to occur between the lug on the right of the carriage case which serves as a bearing for the K5-51D, registering dial clearing gear, and the bushing K843D for the eccentric gear, in K8-11D, bracket for right hand eccentric gear.

It is noted that when shifting a carriage in this manner, the left bumper spring collapses enough to cause the lug in the carriage to strike K843D as described above, with the result that as K8-11D supports the carry counting mechanism on the right of the machine, this mechanism may become distorted and thereby cause it to be out of adjustment, through this repeated interference.

SHIFTING CARRIAGE FORCIBLY IN
DIRECTION OF ARROW COLLAPSES SPRING 'A'
BETWEEN LUGS 'B'-'C' ALLOWING INTERFERENCE
AT POINT 'D'.

TO REMEDY THIS, REMOVE CARRIAGE -
AND FILE OFF ABOUT $\frac{1}{16}$ OF AN INCH AT X
- CAUTION -

PLACE CARRIAGE ON A CLOTH - PROTECT
BEARINGS AND PARTS WHILE FILING BY RAGS
IN PROPER PLACES.
